#### **TECHNICAL INFORMATION REPORT**

Front Street Short Plat 9XX Front Street South Issaquah, WA 98027

**Encompass Engineering Job No. 22679**

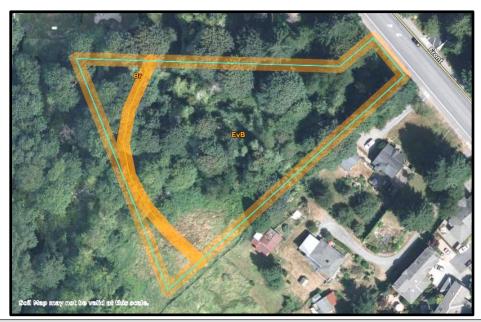
Figure 2: Soils Map and Legend

Map Unit Symbol	Map Unit Name	Acres in AOI	Percent of AOI
Br	Briscot silt loam	0.3	15.6%
EvB	Everett very gravelly sandy loam, 0 to 8 percent slopes	1.6	84.4%
Totals for Area of Interest		1.9	100.0%

Per the US Department of Agriculture (USDA), Natural Resources Conservation Service (NCRCS) Web Soil Survey (WSS) information, the project site is underlain with Everett and Briscot soils (See Figure 2 below). Soils encountered from field explorations by the Riley Group consisted of stiff to very stiff silt with some sand over medium dense gravelly silty sand and sandstone. Based on these soil findings, infiltration is not recommended per the Geotechnical Engineering Report included as Appendix A.
